A Summary of a NIOSH fire fighter fatality investigation

March 19, 1999

Commercial Building Fire Claims the Lives of Two Volunteer Fire Fighters - Mississippi

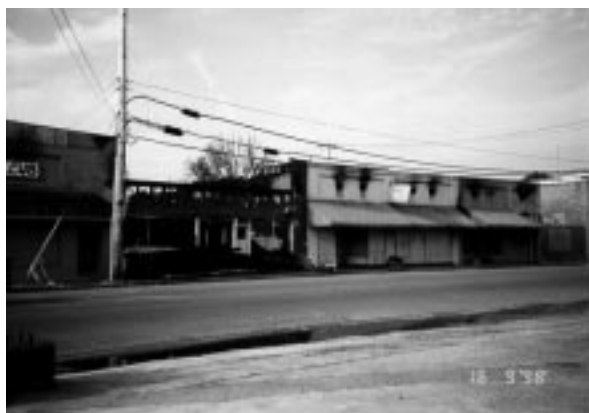
Figure 1. Building where Two Fatalities Occurred.

On August 29, 1998, at 0056 hours Central Standard Time, a volunteer fire department was dispatched to a fire at a commercial building which consisted of five separate stores (see Figure 1). The volunteer fire department responded with two vehicles and a total of 11 fire fighters. Three fire fighters arrived on Engine 12, and Victim #1 arrived shortly thereafter with Engine 9. The seven remaining fire fighters arrived in privately owned vehicles.

The site of the incident was a one-story, commercial building with a brick front exterior and concrete block sides and back. The building consisted of five individual stores with common walls. The roof of the store where the fire occurred was about 30 feet wide, consisted of 2-inch x 10-inch wood joists, and was covered with plywood sheathing and asphalt material (tar). The back wall of the building had been extended several feet for an addition (the ceiling consisted of wooden roof trusses made of 2-inch x 4-inch wooden studs). A partial parapet wall located in the front of the building extended partially down each dividing wall on the store roofs. A drop ceiling was installed with 2-foot by 2-foot tin tiles which were nailed to 1-inch by 4-inch wood runners. The building also included a one-story, attached addition in the rear of the building which was being used for

storage. This storage room had been constructed of concrete block and had a wooden, pitched roof which was covered with asphalt roofing material. None of the stores, including the storage room, was equipped with smoke alarms or sprinkler systems.

Recommendation #9: Owners of commercial buildings should ensure that smoke alarms and sprinkler systems are installed and operable. [1]

Discussion: Fire detection and automatic suppression are extremely important in the control of aggressive fires in buildings and remain the most dependable form of fixed fire protection. If these buildings had been equipped with smoke detectors and an automatic sprinkler system, it may have controlled the spread of the fire and therefore prevented the fatal injuries.

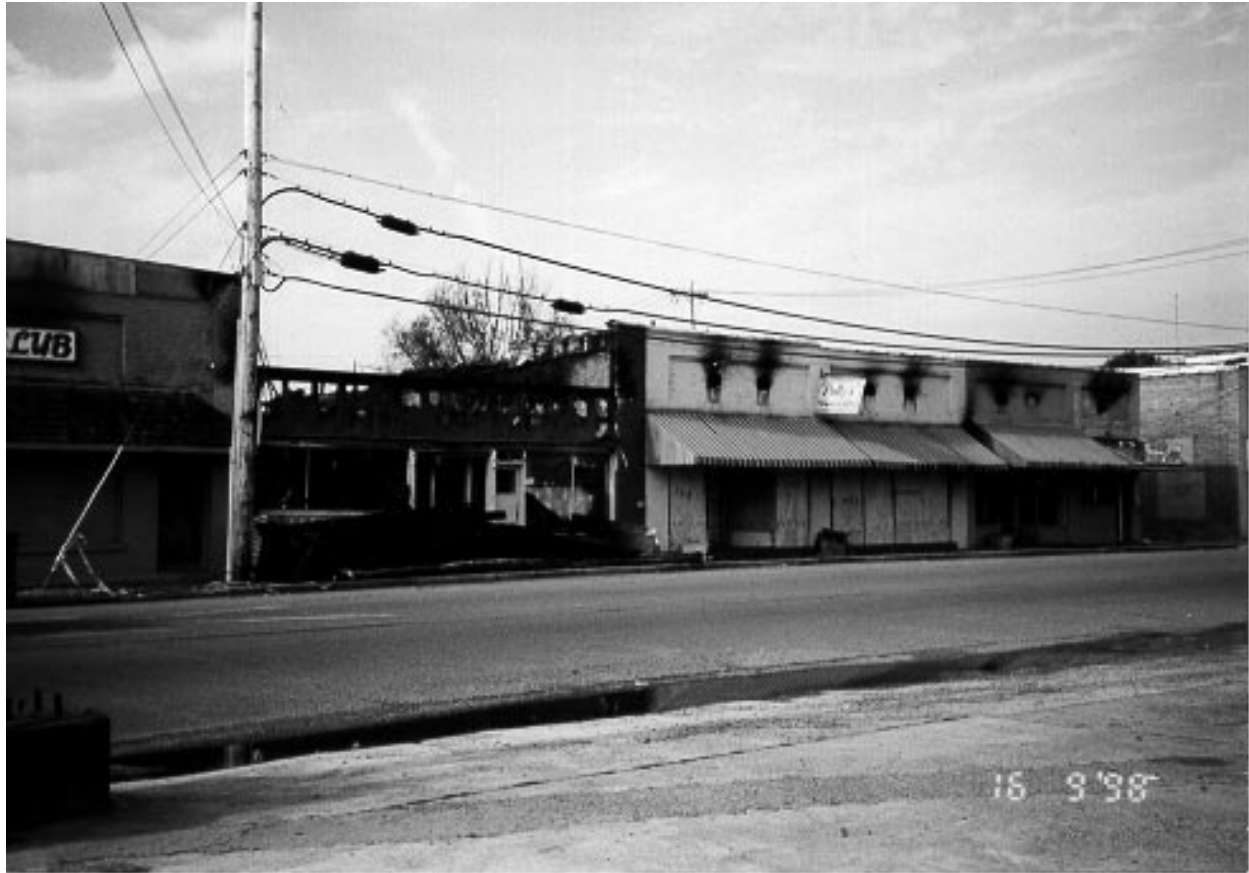
Figure 1. Building Where Two Fatalities Occurred
